**Flood Control Project Maintenance
Levee Inspections**

Fall 2019 Levee Maintenance Deficiency Summary Report

San Joaquin River Basin

Reclamation District No. 2075 McMullin

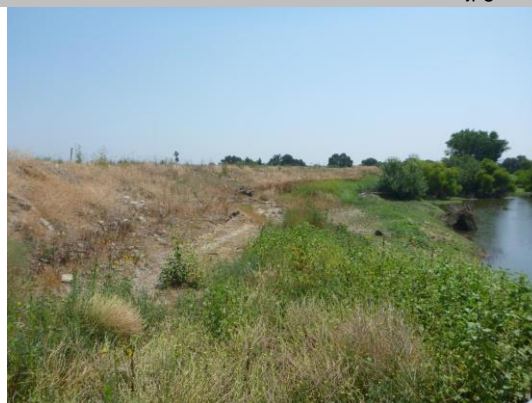
Photo 1 of 3 : LEVAL_FA_2019_578_4248.jpg

LM Start	5.24	Rating **	A/W	Issue No.	21
LM End	5.29	Issue Type +	Ma	Location *	WS
Category	Supplemental			GPS Latitude/Longitude	
				Start	End
Item	2017 Storm Damage			37.728460 °	37.727799 °
				-121.274671 °	-121.274252 °
DWR ID	LMA-484				
Comment Code					
Inspector Comment					
Levee Evaluation Comments					
Description:Slope protection repairs are needed along the waterside slope due to erosion and riprap displacement from high water. Based upon levee inspections, it was determined the waterside levee slope is eroding, deteriorating, and degrading. The eroded levee sections need to be restored back to design standards to prevent further deterioration and damage.					
Site ID No:578					
Site Designation:LMA-484					
Repair Type: Erosion					
Rating:Area of Concern					
Field Date:8/10/2017					
Notes: Paved road on levee.

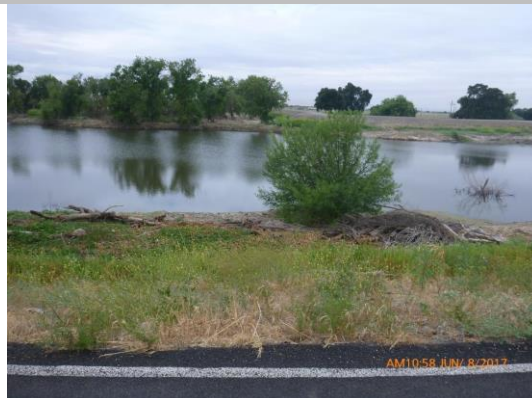
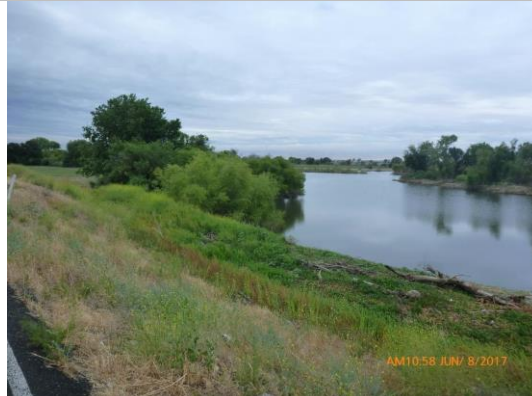
LM Start	5.26	Rating **	A/W	Issue No.	23
LM End		Issue Type +	Ma	Location *	WS
Category	Supplemental			GPS Latitude/Longitude	
				Start	End
Item	2017 Storm Damage			37.728216°	°
				-121.274434°	°
DWR ID	LMA-33				
Comment Code					
Inspector Comment					
Levee Evaluation Comments					
Description:					
Site ID No:79					
Site Designation:LMA-33					
Repair Type: Erosion					
Rating:Area of Concern					
Field Date:6/8/2017					
Notes: no damage present

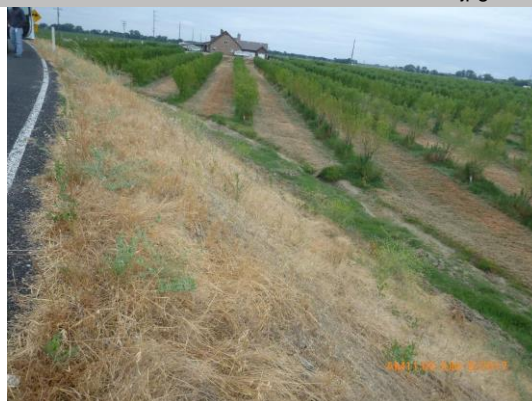
Photo 3 of 3 : LEVAL_FA_2019_79_1337.jpg

LM Start	5.26	Rating **	A/W	Issue No.	23 (cont)	
LM End		Issue Type +	Ma	Location *	WS	
Category	Supplemental			GPS Latitude/Longitude		
				Start	End	
Item	2017 Storm Damage			37.728216 °		°
				-121.274434 °		°
DWR ID	LMA-33					
Comment Code						
Inspector Comment						
Levee Evaluation Comments						
Description:						
Site ID No:79						
Site Designation:LMA-33						
Repair Type: Erosion						
Rating:Area of Concern						
Field Date:6/8/2017						
Notes: no damage present

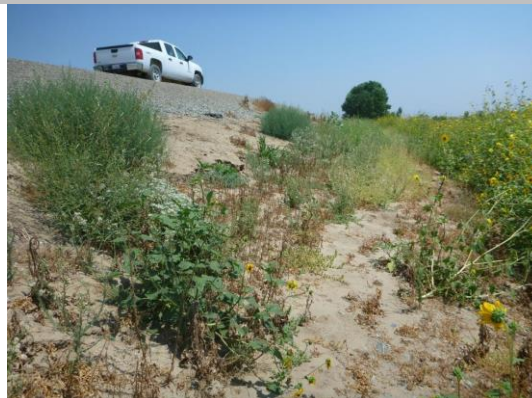
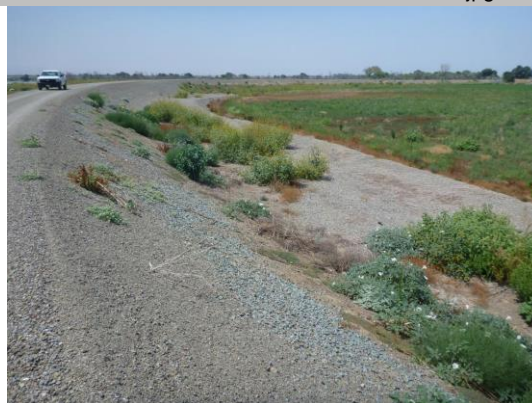
LM Start	5.87	Rating **	A/W	Issue No.	28
LM End	6.33	Issue Type +	Ma	Location *	WS
Category	Supplemental			GPS Latitude/Longitude	
				Start	End
Item	2017 Storm Damage			37.721710 °	37.720960 °
				-121.267490 °	-121.259830 °
DWR ID	LMA-485				
Comment Code					
Inspector Comment					
Levee Evaluation Comments					
Description:Slope protection repairs are needed along the waterside slope due to erosion and riprap displacement from high water. Based upon levee inspections, it was determined the waterside levee slope is eroding, deteriorating, and degrading. The eroded levee sections need to be restored back to design standards to prevent further deterioration and damage.					
Site ID No:579					
Site Designation:LMA-485					
Repair Type: Erosion					
Rating:Area of Concern					
Field Date:8/10/2017					
Notes: Berm present on LS. LMA 486 is combined with this site.

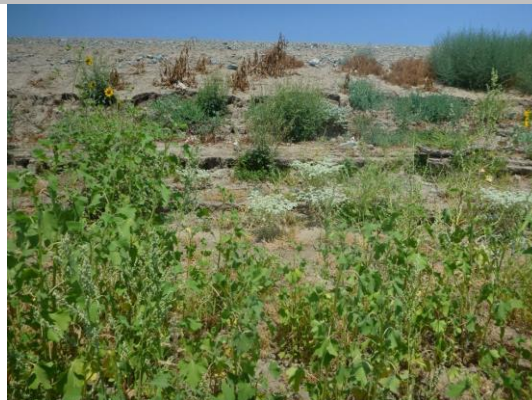
Photo 3 of 3 : LEVAL_FA_2019_579_4275.jpg

LM Start	5.87	Rating **	A/W	Issue No.	28 (cont)
LM End	6.33	Issue Type +	Ma	Location *	WS
Category	Supplemental			GPS Latitude/Longitude	
				Start	End
Item	2017 Storm Damage			37.721710 °	37.720960 °
				-121.267490 °	-121.259830 °
DWR ID	LMA-485				
Comment Code					
Inspector Comment					
Levee Evaluation Comments					
Description:Slope protection repairs are needed along the waterside slope due to erosion and riprap displacement from high water. Based upon levee inspections, it was determined the waterside levee slope is eroding, deteriorating, and degrading. The eroded levee sections need to be restored back to design standards to prevent further deterioration and damage.					
Site ID No:579					
Site Designation:LMA-485					
Repair Type: Erosion					
Rating:Area of Concern					
Field Date:8/10/2017					
Notes: Berm present on LS. LMA 486 is combined with this site.
